# NDSU-North Dakota Forest Service

*Report Date: October 25, 2011*

## General Sibley Park Assessment Bismarck Parks and Recreation District

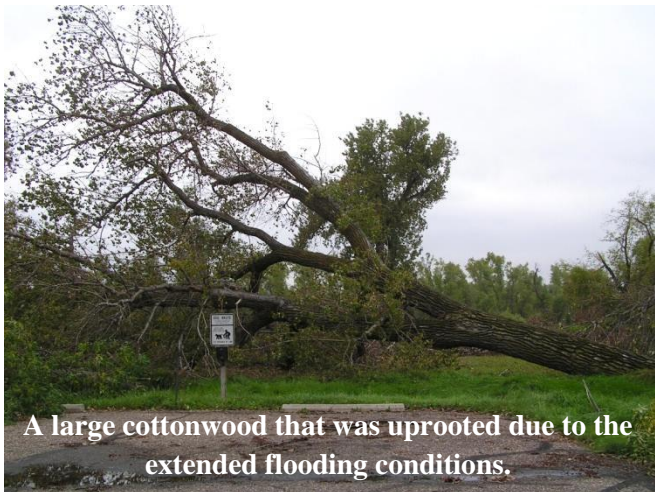
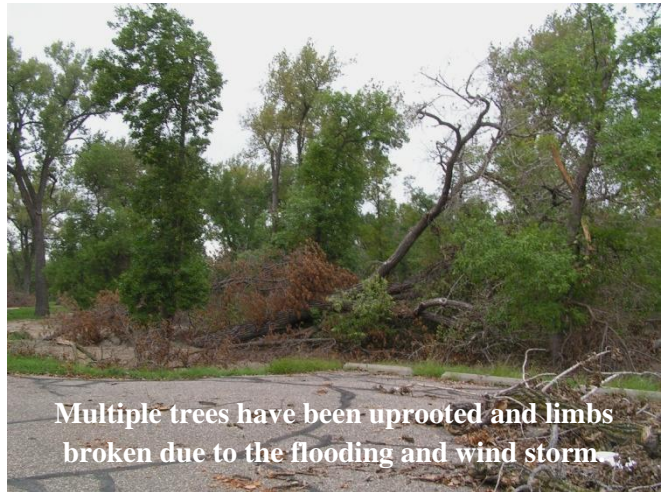
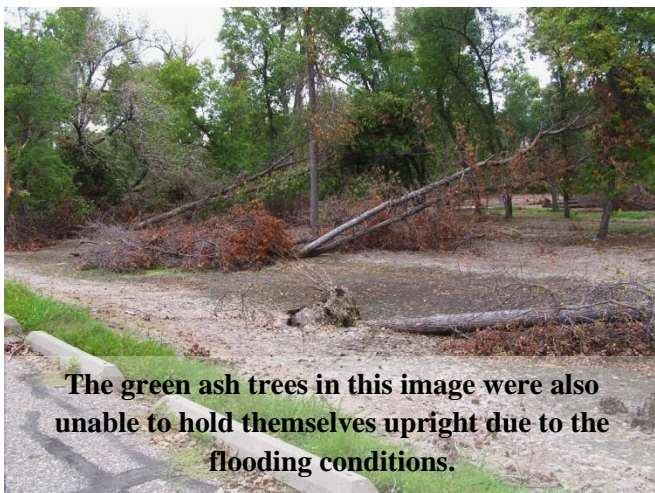
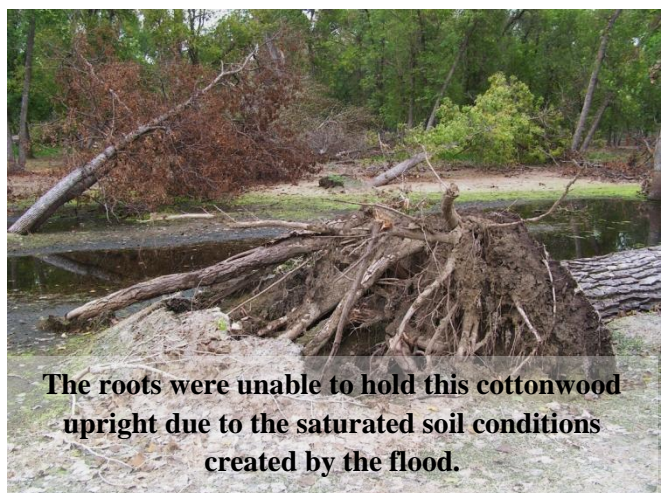
The following images were from the initial visit to General Sibley Park. Although they represent a small area of the park, the images illustrate the devastation that was found throughout the park.

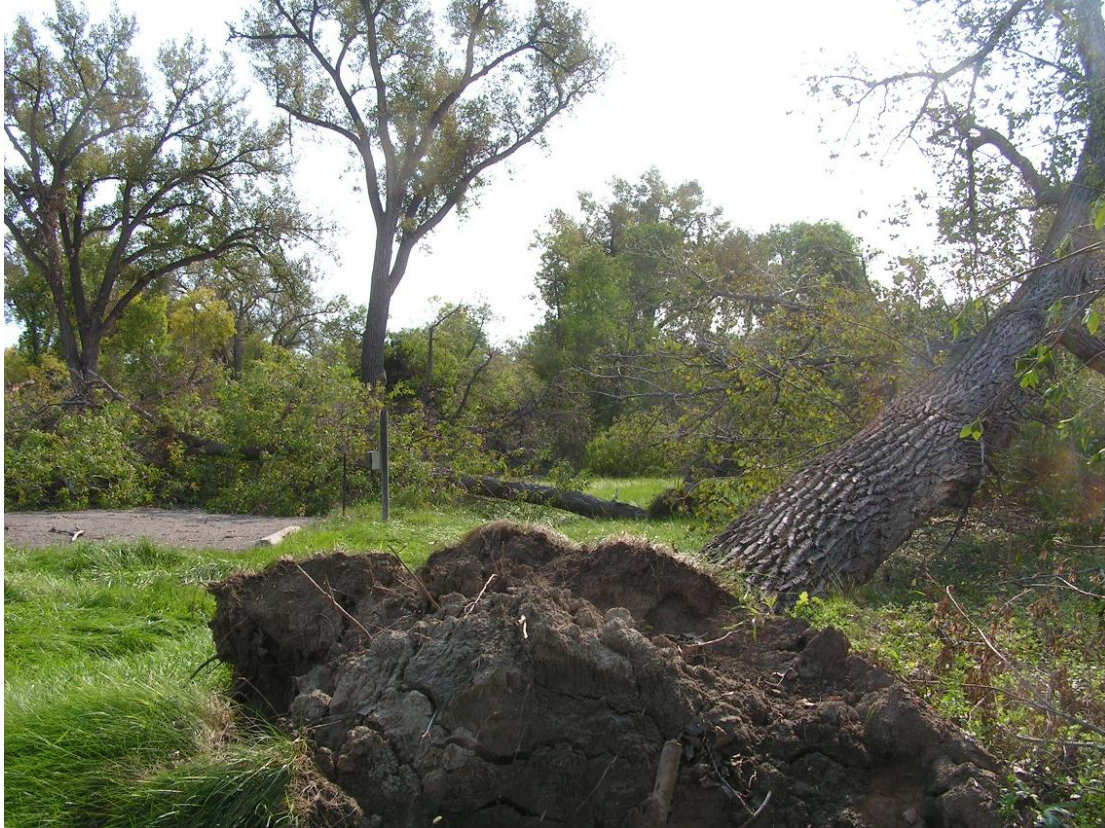
The windstorm on July 31, 2011, played a role in toppling trees in the park, but flooding is the primary factor that caused so many trees to fall. The image above shows trees that toppled in different directions indicating it was the soil and roots that gave way; and the windstorm was a contributing factor in many cases.

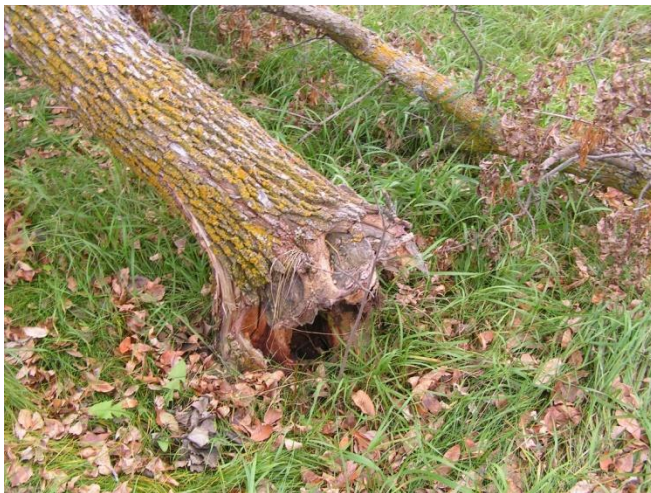
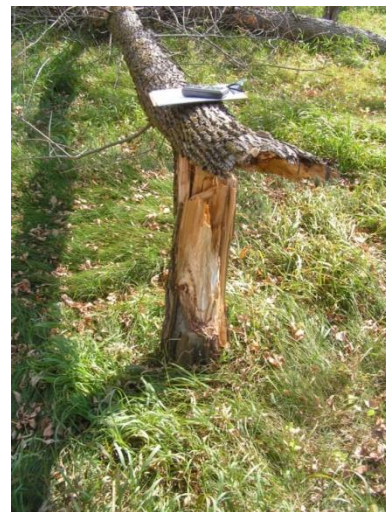
The image to the left shows the trunk failed at ground level, while the image to the right indicates the failure occurred further up the tree trunk. The trunk breakage was caused by a wind storm, but mechanical damage in the past may have weakened the wood. Every effort should be

made to prevent mechanical damage from string trimmers and lawnmowers during maintenance operations. Repeated injury decreases the overall health of the tree and allows access for wood-decaying pathogens to enter the tree. These trees might have survived the windstorm if there had not been previous mechanical damage.

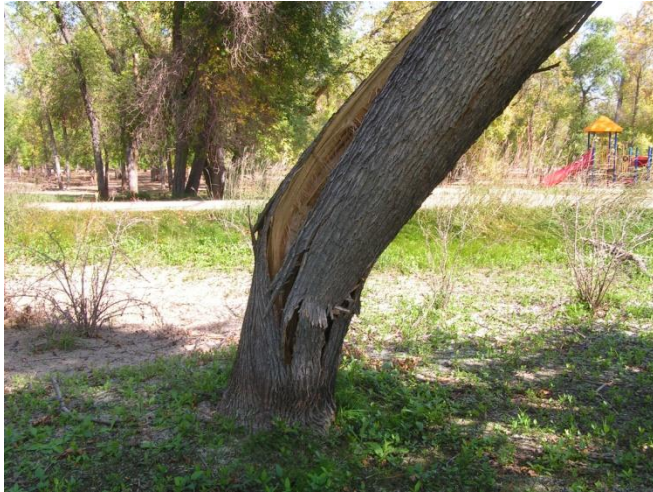
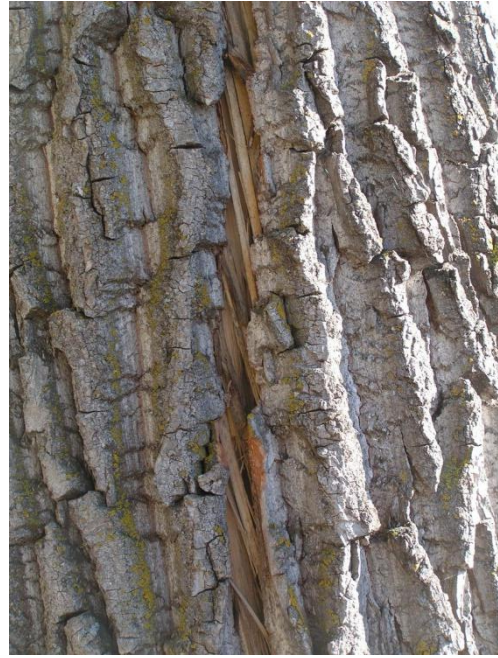
The trunk failure on the green ash tree above shows damage from the wind storm. The image to the right is splitting damage to the trunk of a cottonwood. The injuries these trees suffered were not due to flooding.

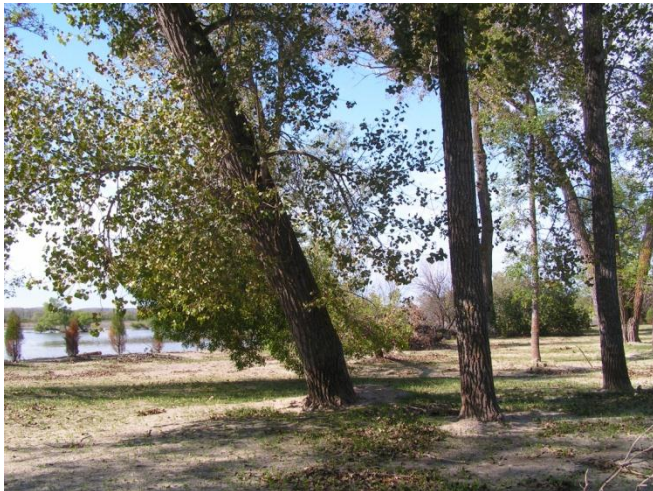
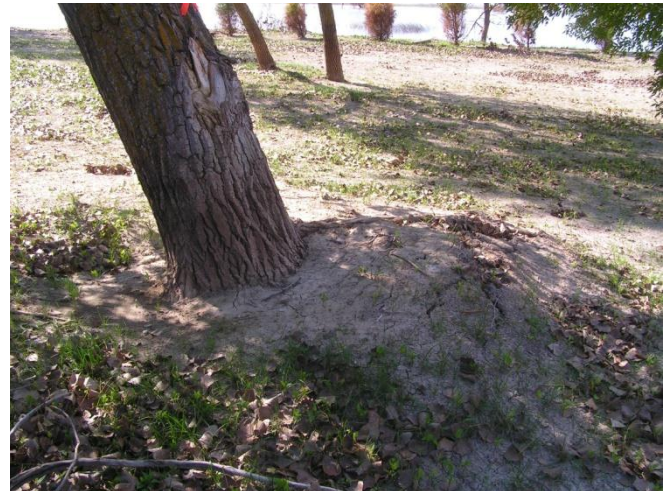
The cottonwood above is still standing, but is leaning because of root damage caused by saturated soils; the image to the right shows that the roots are failing and the tree should be removed. Trees with similar or more excessive lean and bulging soil on one side should be removed. The tree is now off center, with the weight of the tree pulling on the roots that have already failed. It is only a matter of time before this tree finally topples over.

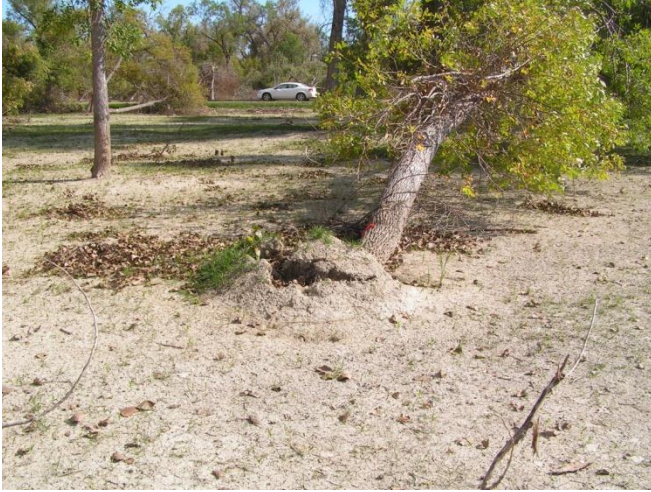
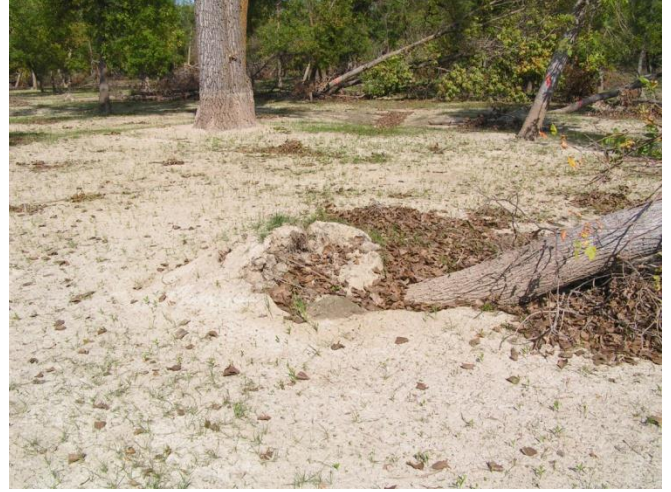
The roots of the green ash pictured above have completely failed due to the flooding. The tree poses an obstacle to maintenance equipment and a tripping hazard for park visitors. Trees that have completely failed like this should be removed.

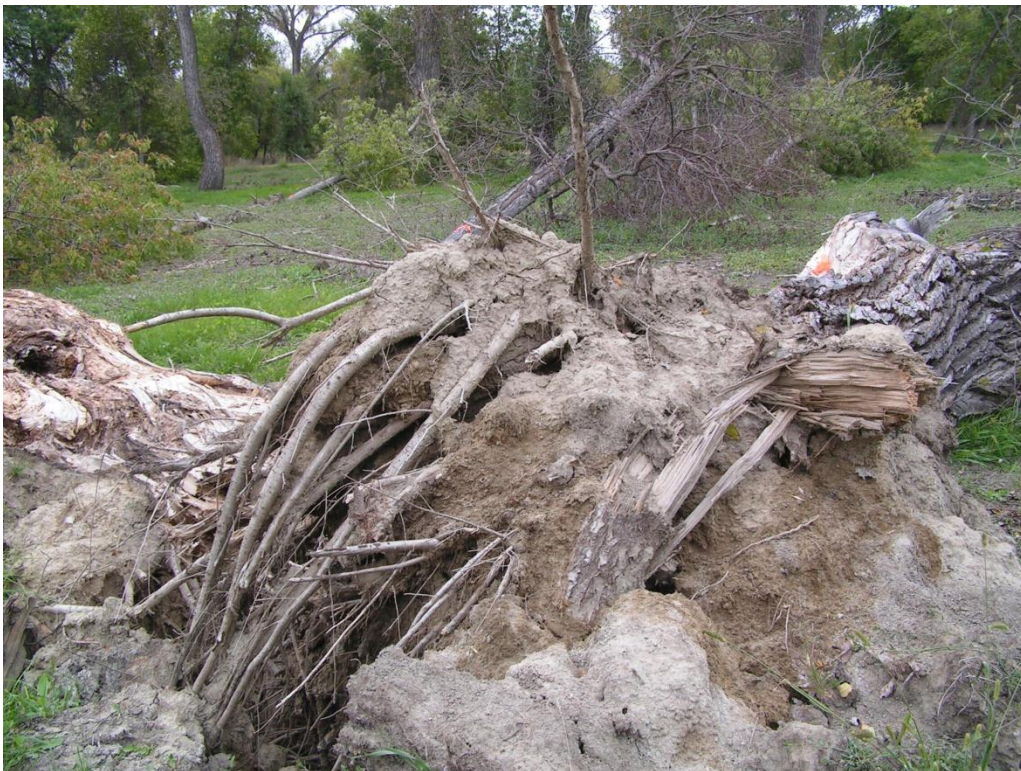
This image shows the roots of a toppled cottonwood tree; only the largest roots have broken, the other roots are bent but intact. The saturated soil, due to the flooding, resulted in root failure.

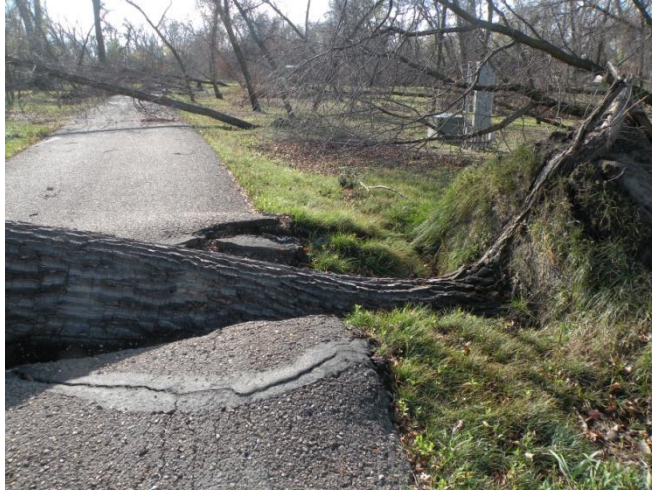
In some locations, not only were trees lost, but the pavement was damaged when the trees fell. Utility lines, in several locations, were also downed as trees fell.

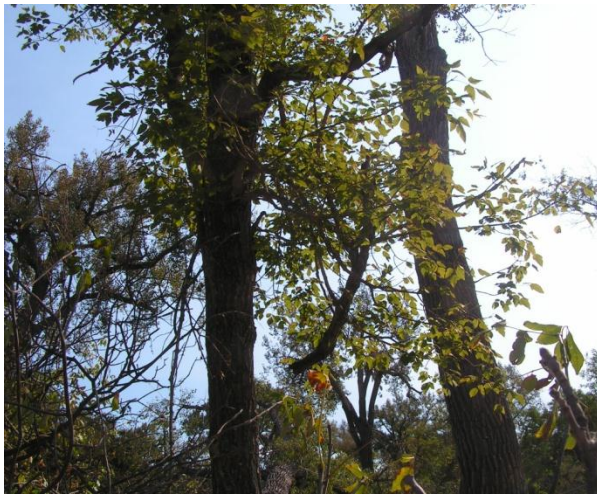
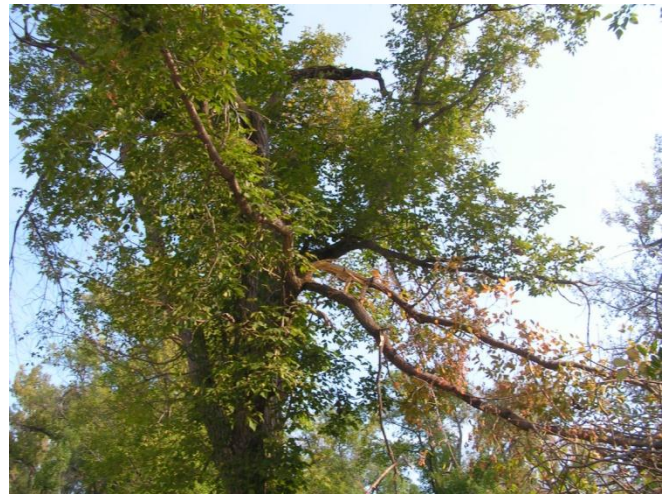
Hanging and broken branches were not documented in this assessment, but they do pose a serious threat to structures, vehicles and patrons of the park when they fall. Once the fallen and severely damaged trees have been removed from the park, hanging and broken branches should also be removed.

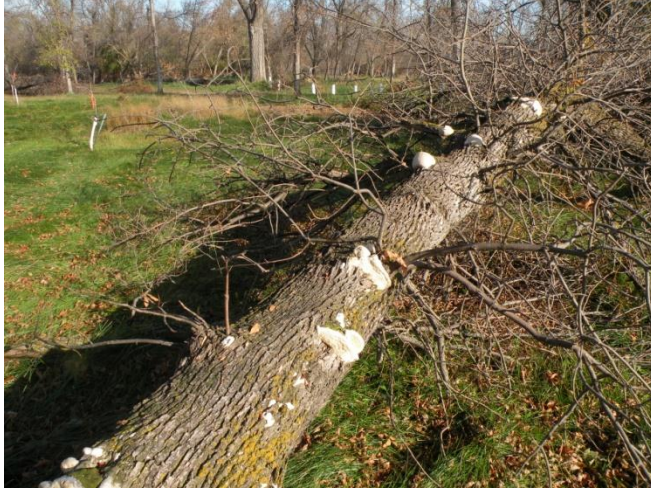
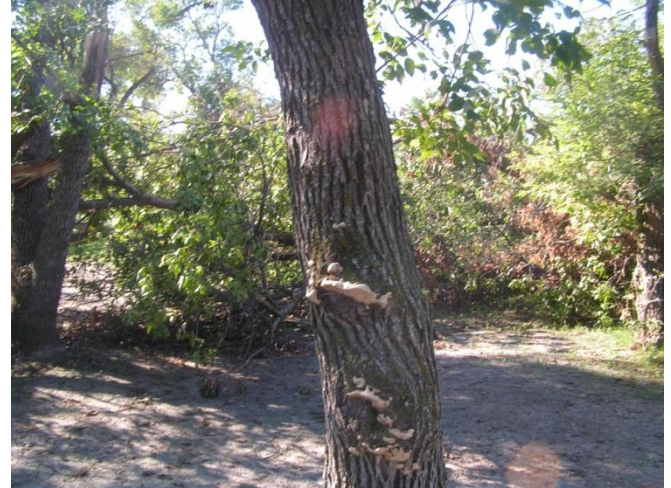
Many of the green ash trees in the park are showing symptoms of heart rot, a fungal disease that deteriorates the strength of the wood slowly over time. The images below show the fruiting bodies of the fungus called conks.

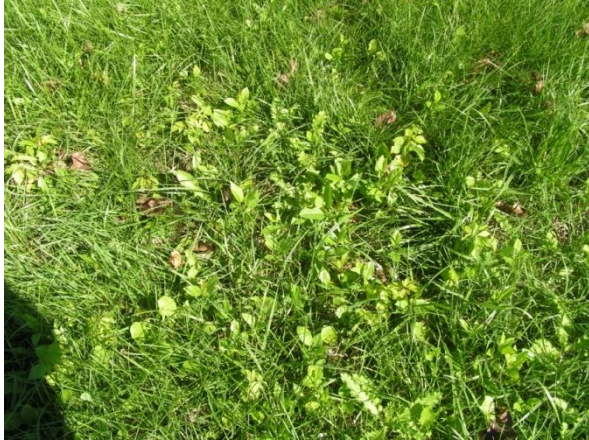
New tree regeneration is emerging since the end of the flood. This image shows new green ash and boxelder seedlings growing in the previously flooded area. These new seedlings could be protected to help reforest parts of the park. New tree regeneration should be managed and protected for at least five-years to avoid damaging the young trees. Care should be exercised to avoid mowing or spraying the seedlings with herbicides. This management approach may work best on the edges of the park

that are not used as intensively as the camping or playground areas. In these high-use areas, replacement planting with commercial nursery stock may be warranted. Increasing the park's overall tree diversity could be accomplished by planting a variety of tree species in these areas.
