# Feedlot Runoff Monitoring Results from Three Years of Snowmelt Events

Ron Wiederholt

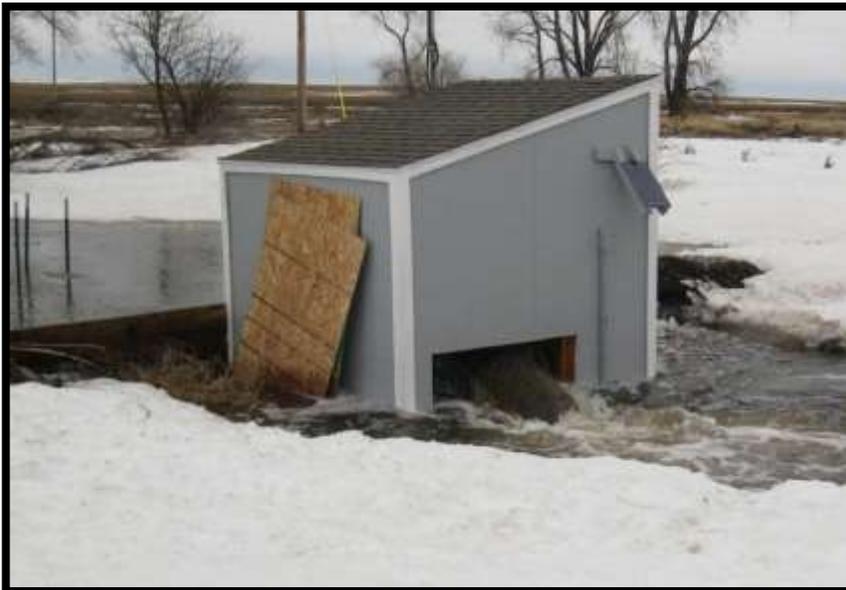
**Monitoring station at Underwood Discovery Farm.**

Gaging station 1 (G1) is installed to capture the runoff that is funneled to a natural exit point directly at the edge of the feedlot. Gaging stations 2 (G2) and 3 (G3) are installed  $\frac{1}{4}$  and  $\frac{1}{2}$  mile, respectively, down-landscape from the feedlot. G2 and G3 were installed to determine the impacts of feedlot runoff flowing through a heavily grassed and wooded drainage area as well as the effect of cropland runoff that enters the drainage area directly above G2. G1 measures the runoff from about 30 acres while G2 and G3 measure the possible runoff from nearly 600 acres. There is no runoff containment or diversions installed at the feedlot. There are tree or building windbreaks on the north and northwest sides of the feedlot.
