## **An Update from the Discovery Farms Project**

**Paulo Flores**

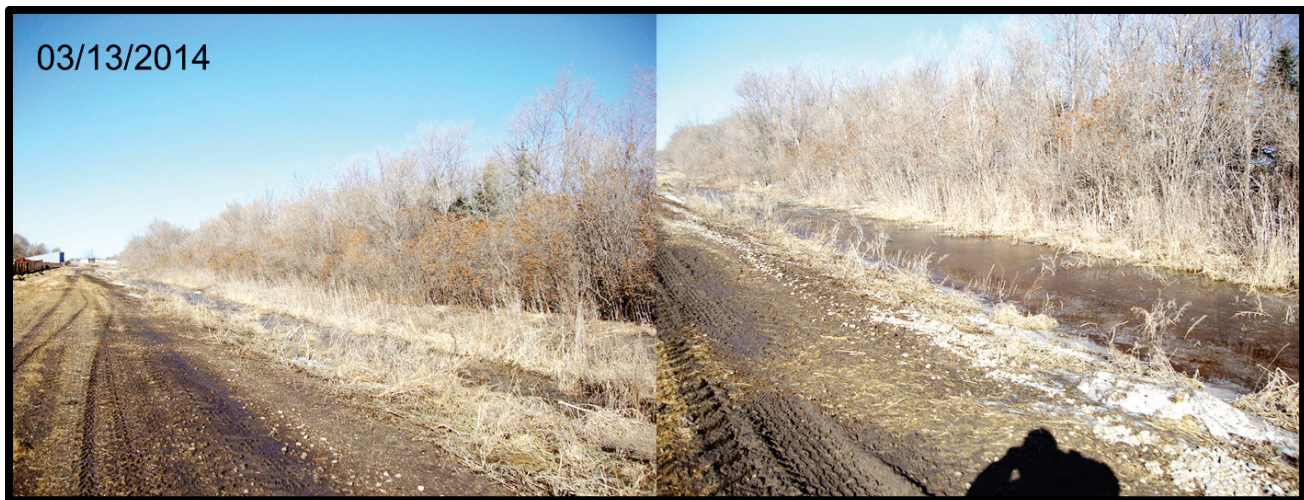
**Figure 1. View of the clean water diversion system during later 2014 winter. The structure is located on the north and east side of the feedlot (partially seen on the left photo).**

At the Underwood site, it seems that the clean water diversion BMP installed in 2012 is having a positive impact on the water quality. This is especially evident at the U1 gaging station, which had substantial decreases in the yields of suspended sediments, total P, ammonia and chloride from 2011 (before the clean water diversion) to 2013 (after the installation of the clean water diversion). The data suggest the BMP is working, but further monitoring is necessary to confirm these preliminary findings.
