CREC Canadian Hazelnut Plant Notes 2018

- These are FI hybrids of (wild hardy American Hazelnuts x cultivated European Hazelnuts) x tame Oregon pollen.
- We expect ¼ to be very hardy, ½ to be reasonably hardy with occasional partial dieback and ¼ to die as soon as they grow above the snowline.
- We also expect ¼ to have large nuts, ½ to be average size and ¼ to be puny.

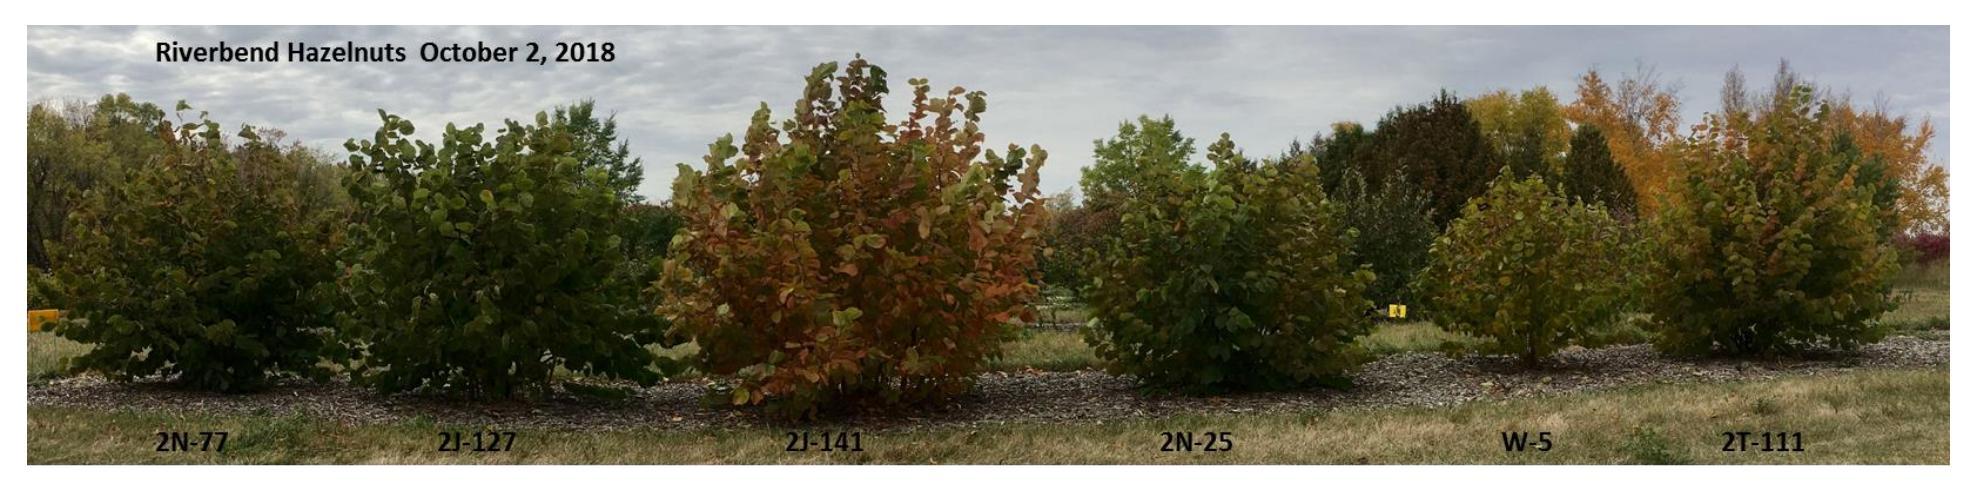
Plant 1: This has been the biggest, healthiest plant over the years. For the first time in 2018, I saw 'cold damage' in that there were dead branches on the north side of the plant.

May 2018 – the first time plant #1 had damage (on the right side).
